Phase I Environmental Site Assessment and Limited Phase II Investigation

Midtown Bridge Street
Hackensack, New Jersey
Block 308.01, Lot 3

April 2014

JMS Project # 2014.056

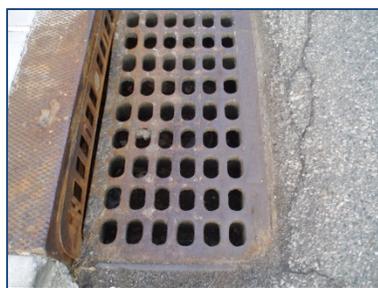
6.3.1 Storm Water Sewer System

One storm water sewer system was identified at the Property. The storm water sewer system consisted of 18 catch basins located on or immediately adjacent to the Property. General refuse and litter was identified in several catch basins, however no significant staining or evidence of discharge of hazardous materials was identified. The locations of the catch basins are illustrated on Figure 2.

One storm water sewer system was identified at the Property. The storm water sewer system consisted of 18 catch basins located on or immediately adjacent to the Property. General refuse and litter was identified in several catch basins, however no significant staining or evidence of discharge of hazardous materials was identified.

Therefore based on available information, this is not an REC and no further investigation is recommended.

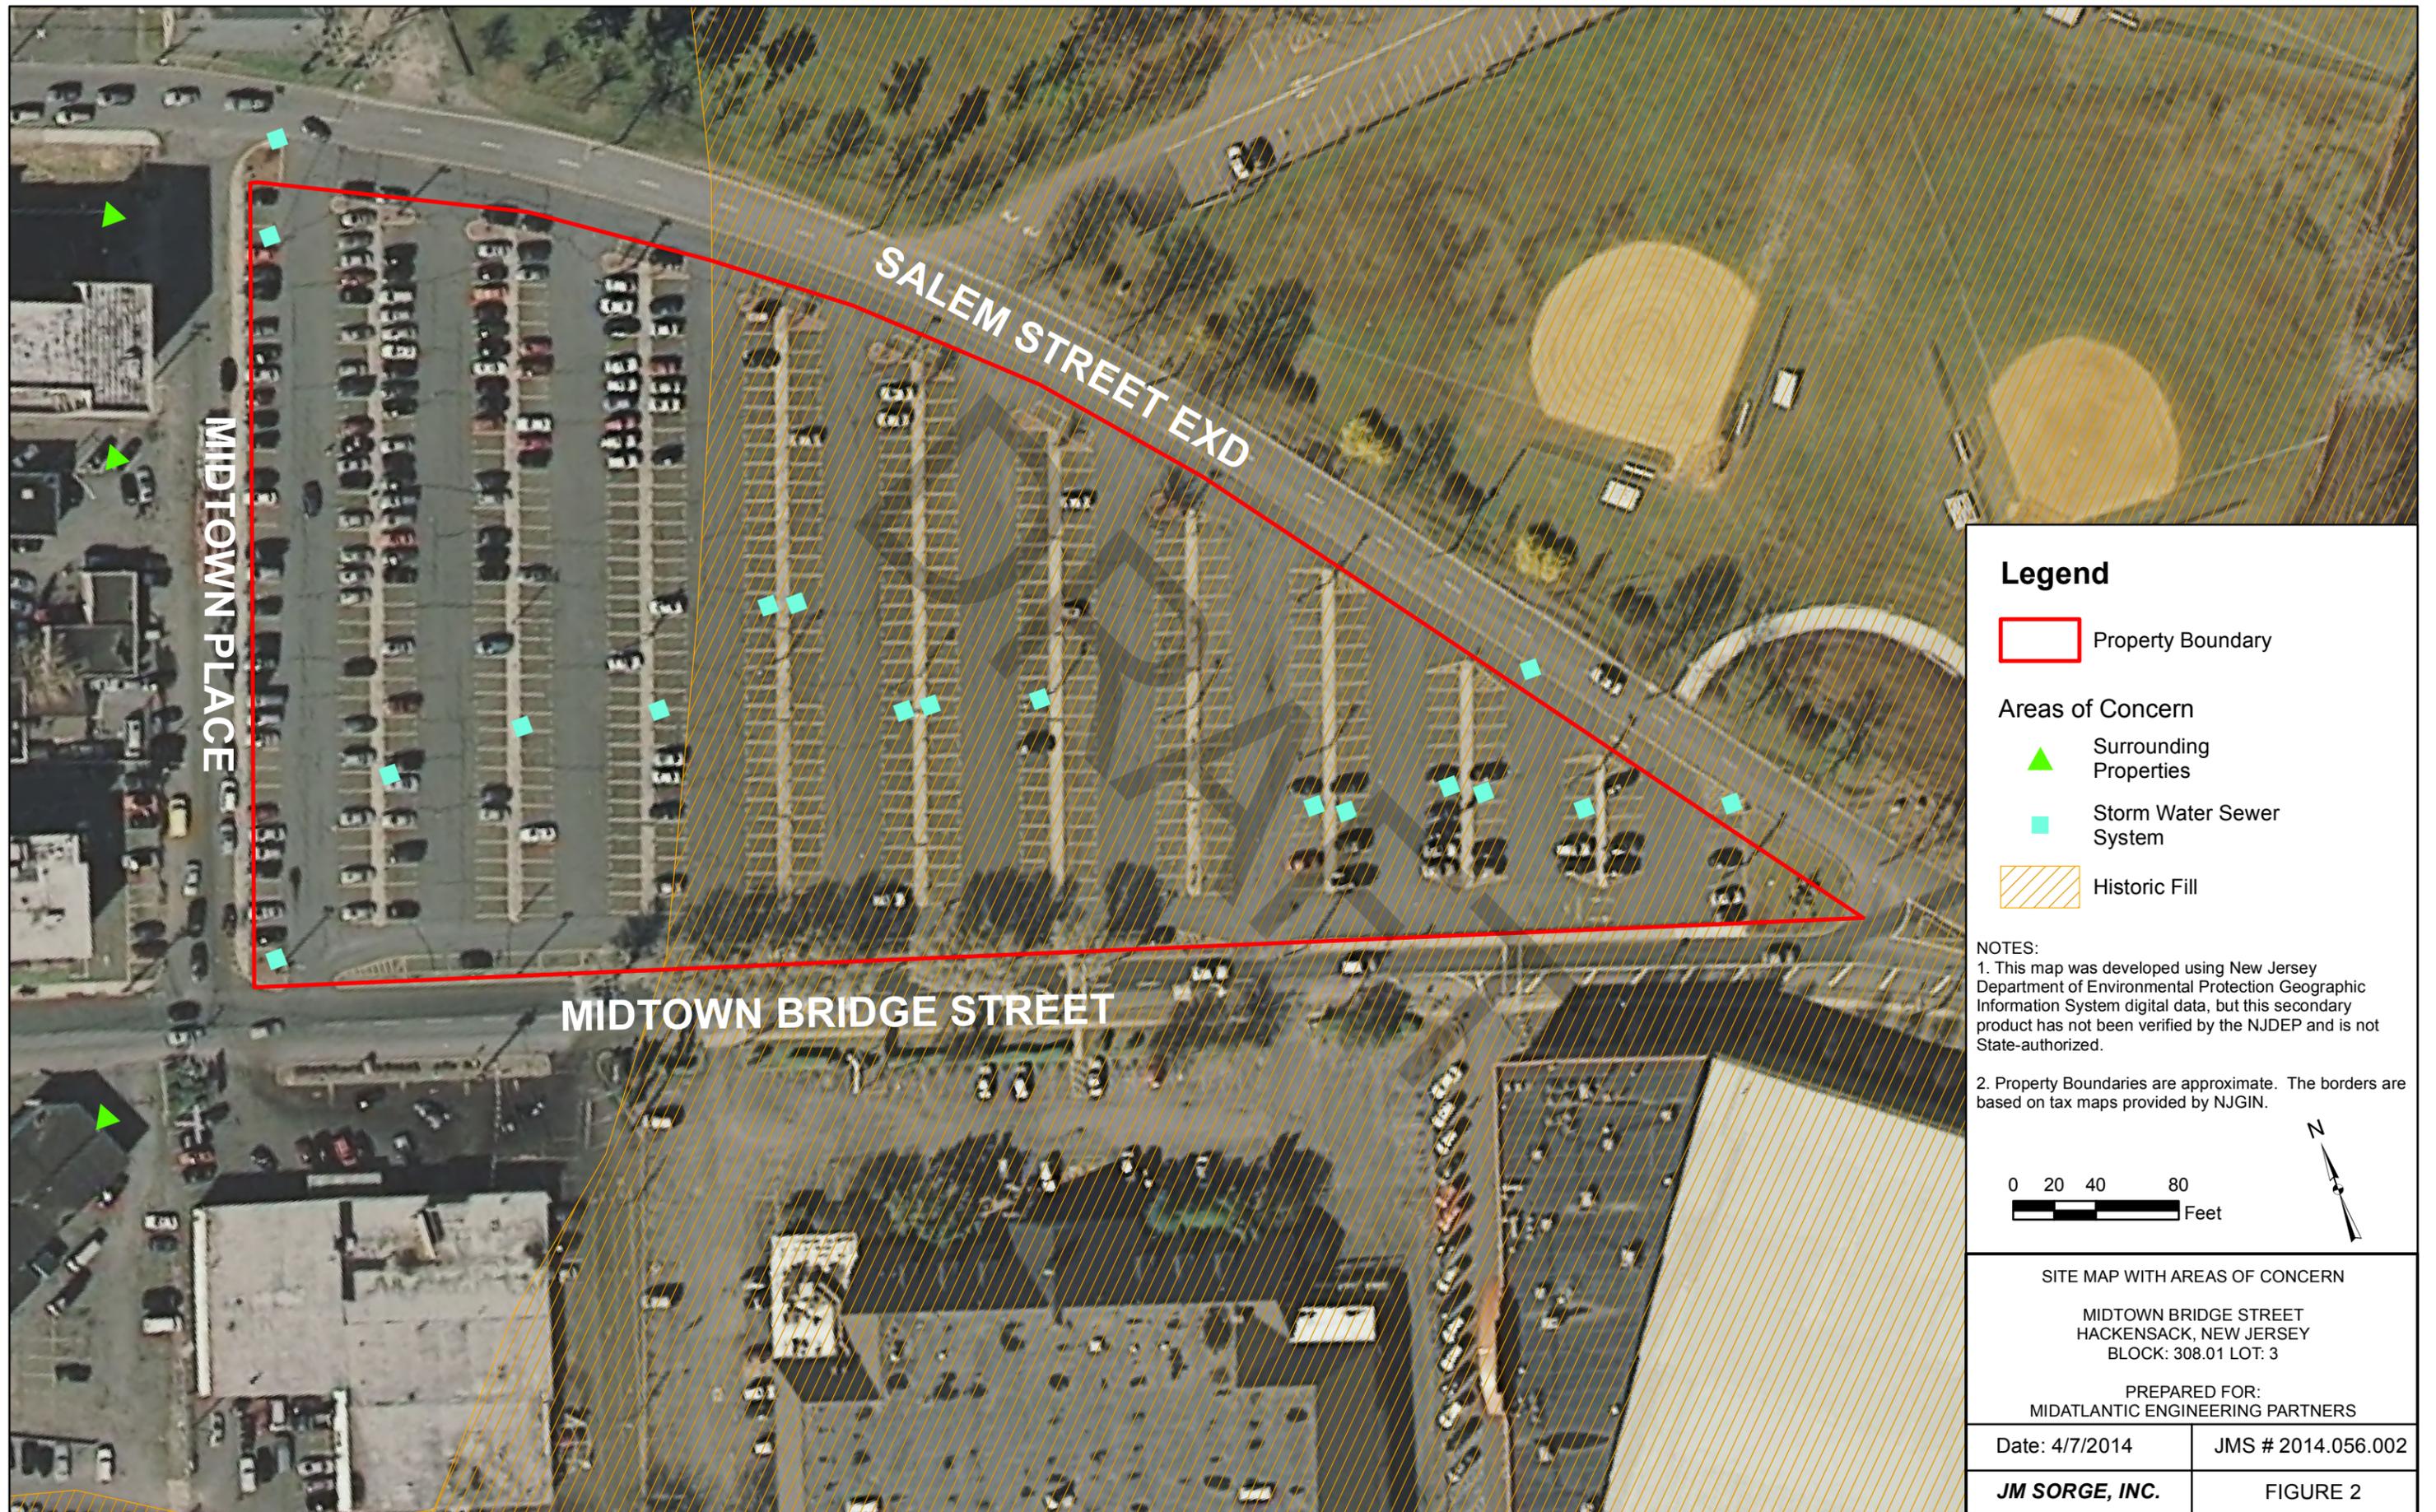
During JMS' site inspection, several surrounding properties were identified which may be potential environmental concerns. Surrounding properties include several auto repair and auto body shops. One site, identified as the former Circle Tire Service, Inc., was demolished, and fenced in. Several monitoring wells were observed on and adjacent to this site. The locations of these surrounding properties are illustrated on Figure 2.

An environmental database search identified several potential environmental concerns at sites in the area surrounding the Property. Several auto repair and auto body shops were identified across Midtown Place. One site (Circle Tire Service, Inc.), is associated with NJDEP PI No. 003040, and an open spill number (NJDEP Case No. 90-09-26-1554) for with gasoline soil and groundwater contamination. A review of NJDEP's online records indicates remedial investigation of this contamination has not yet been completed. JMS contacted the LSRP for the site, Mr. John Hernandez of Brennan Environmental, Inc., however no additional information was received.

During JMS' site inspection, the former Circle Tire Service building was no longer present, and the site was fenced in. Several monitoring wells were observed on and adjacent to this site. Therefore based on available information, this is an REC and further investigation is recommended.
